# COLD WAR

**BERLIN**

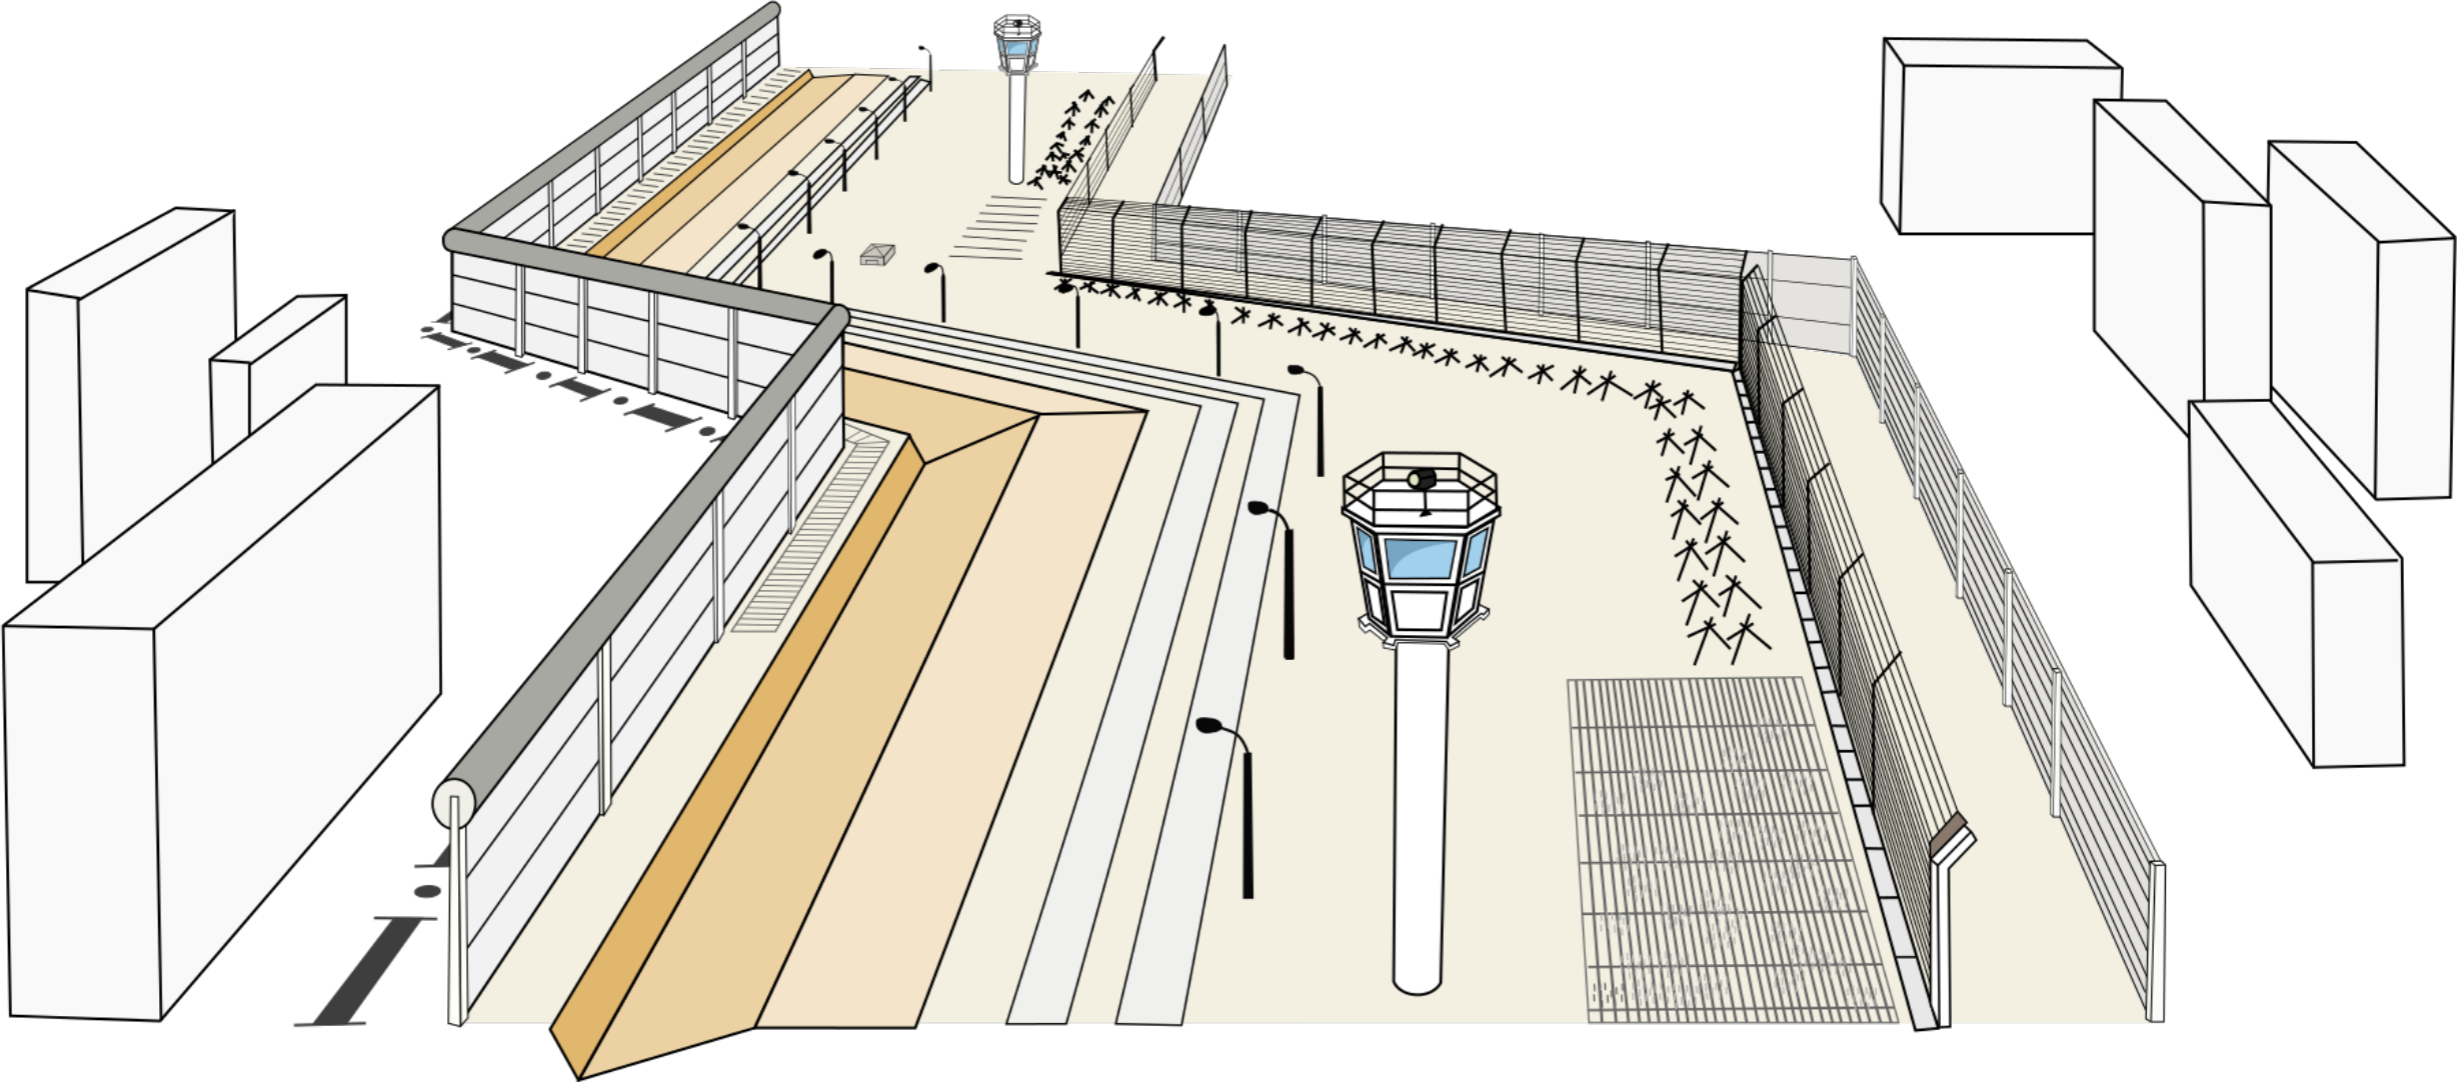
**BOUNDARY WALL**  
The final barricade facing West Berlin was rebuilt and strengthened four times. The last version, finished in 1976, was a four-metre reinforced concrete upright with a flaring L-shaped base designed to thwart attempts to batter through the wall with armoured vehicles or transport trucks. It was capped with a wide concrete sewage pipe that made it impossible for any would-be climber to get a firm grip.

**ANTI-VEHICLE TRENCH**  
Over 100 kilometres of trench was dug at intervals, designed to trap heavy vehicles trying to bulldoze their way across.

**ROUND WATCHTOWER**  
Between 1966 and 1972, over 200 of these sophisticated concrete watchtowers were built to replace older wooden ones. Window shutters were made of steel, in case the enemy in the West opened fire. One still stands near Potsdamer Platz as a historical memento.

**DOGS**  
Guard dogs patrolled a strip between the signal fence and the patrol road, tethered to a long metal guide rail.

**DEATH STRIP**  
This six-metre wide zone was seeded with land mines and covered with carefully raked sand, revealing the footprints of would-be escapees. The evidence was often used to determine if guards had been negligent at their posts.

**WATCH TOWER**  
Every one of the 302 guard posts that ringed West Berlin was staffed 24-hours-a-day by a contingent of between two and five soldiers, each working an eight-hour shift. They were placed at regular intervals of a few hundred metres, allowing a direct line of sight between them.

**CZECH HEDGEHOGS**  
These iron anti-vehicle stanchions were developed during the Second World War as anti-tank obstacles.

**SIGNAL FENCE**  
This barbed-wire barricade doubled as a crude escape detector. Anyone climbing it would press wires together and complete a circuit that would trip an alarm in the watchtower.

**HINTERLAND WALL**  
This three-to-four-metre wall was the first barrier East Germans faced.
